DET NORSKE VERITAS

Final Report

Dissecting Coating Disbondments

Report No./DNV Reg No.: ENAUS 811 Brossia (101131)
Rev 1

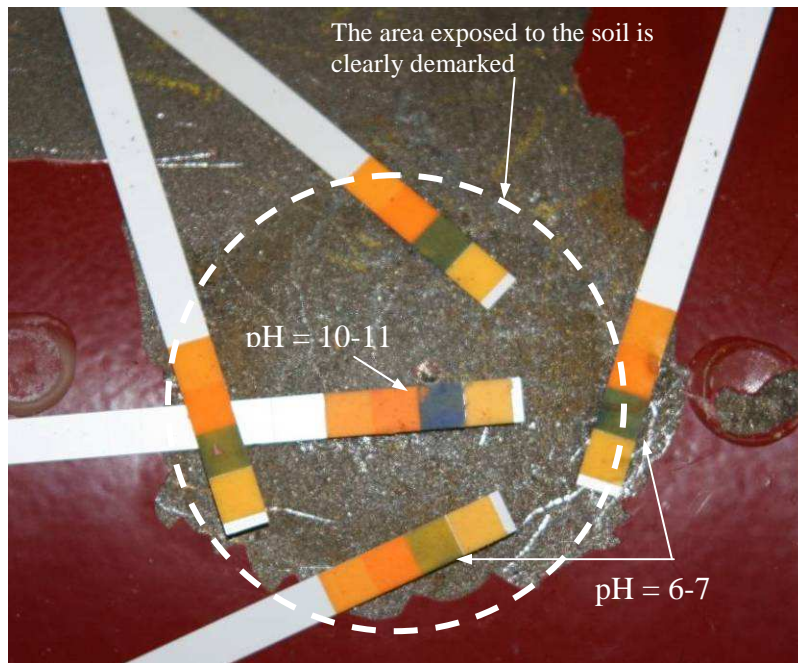
To determine the actual extent of the damage, the coating was gently scraped off using a utility knife. All the coating that was easily peeled with the knife was removed. The surface pH was measured at the defect and, at least, at four other locations to determine if a possible gradient in pH along the failed surface existed. Results are shown in Figure 26. As seen in Figure 26, the pH was approximately 10-11 in the region surrounding the defect; but was nearly neutral everywhere else. Figure 27 shows the results of a control test performed on the same pipe away from the affected area. The test was conducted to determine whether the large extent of coating failure was somehow related to defective or poor coating application. As seen in Figure 27, peeling of the coating was difficult and confined to the area near the CDT exposure area. Although a defective coating due to application errors should not be completely ruled out, these results seem to confirm that the disbonded region extending outside the area exposed to the CDT was likely caused by the CDT experiment itself. Possible explanations for this observation will be discussed later.

Figure 26. Extent of the attack and pH indication after test on as-received section B

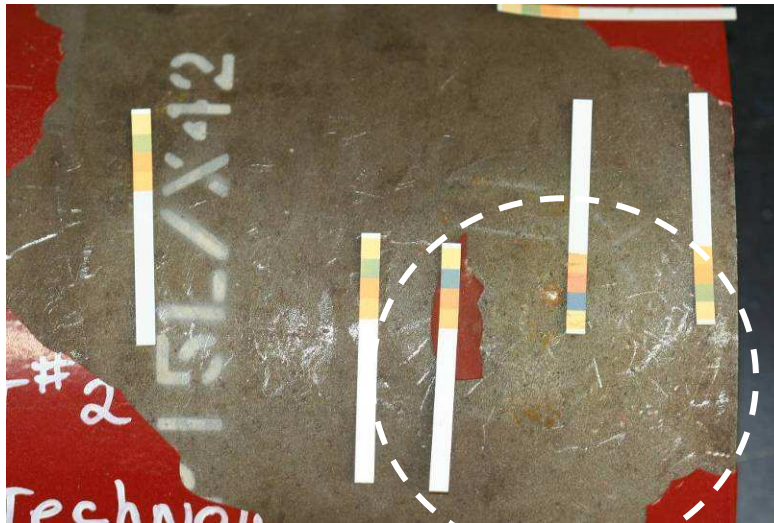
measured before CDT testing. The objective of the chloride pre-treatment was to evaluate how the presence of chloride affects ionic migration. The surface pH was 6-7 everywhere but at the proximities of the defect, where the pH reached 10-11. The back side of the failed coating near the defect also showed a pH of 10-11.

Figure 28. Extent of the attack and pH indication after test on chloride pre-treated pipe.

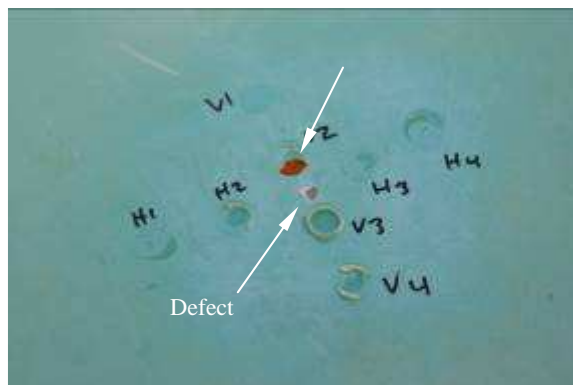
Results obtained for aged FBE in both 0.5 M NaCl and soil environments were in line with the results obtained for new FBE coatings. Adhesion strength before testing always surpassed the strength of the adhesives used to attach the dollies. No failure of the FBE coating occurred before the CDT. After testing, however, failures were observed at locations near the defect from where hydrogen evolution was readily visible, Figure 31. Adhesion strength on failed spots varied from 362 to about 1600 psi. The surface pH was always near neutral and the chloride content below 31 ppm. IEC analysis (Table 21) confirmed the surface chemistry measured using the Bresle patches.

Figure 31. Pull-off adhesion measurements showing a failed spot near the defect.

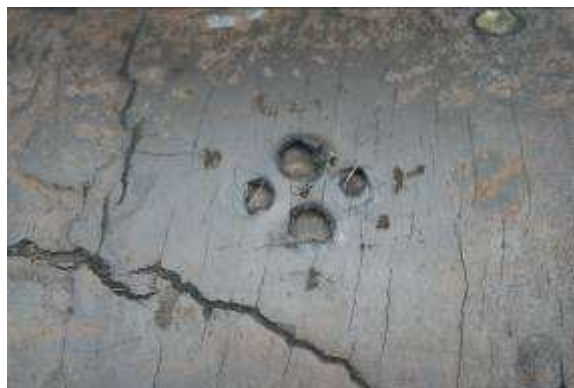
However, the overall response of the RCT was better than that of CTE coatings as the main failure mode was cohesive. The pH on the failed areas was nearly neutral and the chloride content below 31 ppm. IEC analysis confirmed the chloride contents measured with the Bresle patches. Only two locations showed elevated chloride contents of 14 and 93 ppm compared to all other locations that were less than 5.4 ppm.

Figure 32. Pull-off adhesion measurements showing a failed spot near the defect.

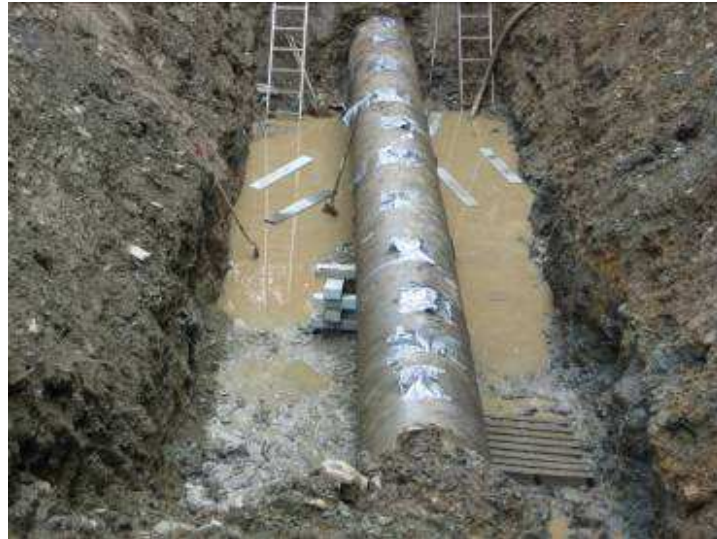
Figure 51. Water flooded the ditch, removing some of the dollies located at the 6 o'clock position.
